SUSQUEHANNA RIVER BASIN
ANDERSON CREEK, CLEARFIELD COUNTY
PENNSYLVANIA

DuBOIS RESERVOIR
NDI No. Pa. - 424

PHASE I INSPECTION REPORT
NATIONAL DAM INSPECTION PROGRAM

PREPARED BY
GAI CONSULTANTS, INC.
570 BEATTY ROAD
MONROEVILLE, PENNSYLVANIA 15146
AUGUST 1978

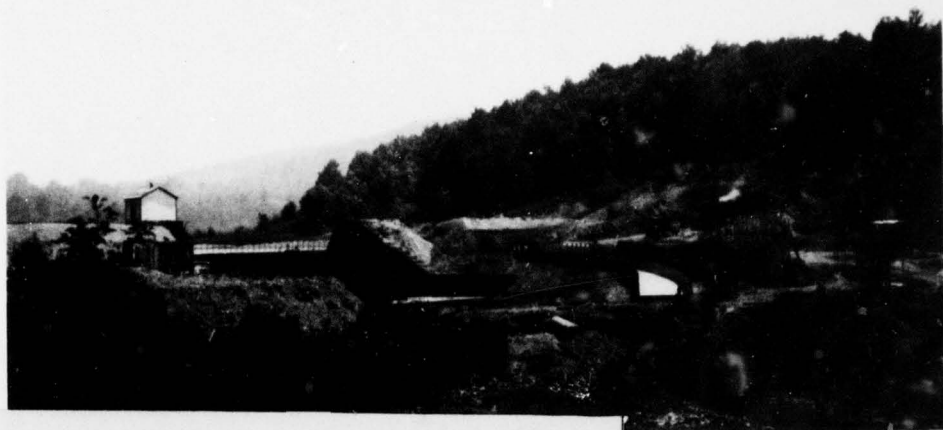
PHOTOGRAPH 1 View of DuBois Reservoir as it appeared in 1919.

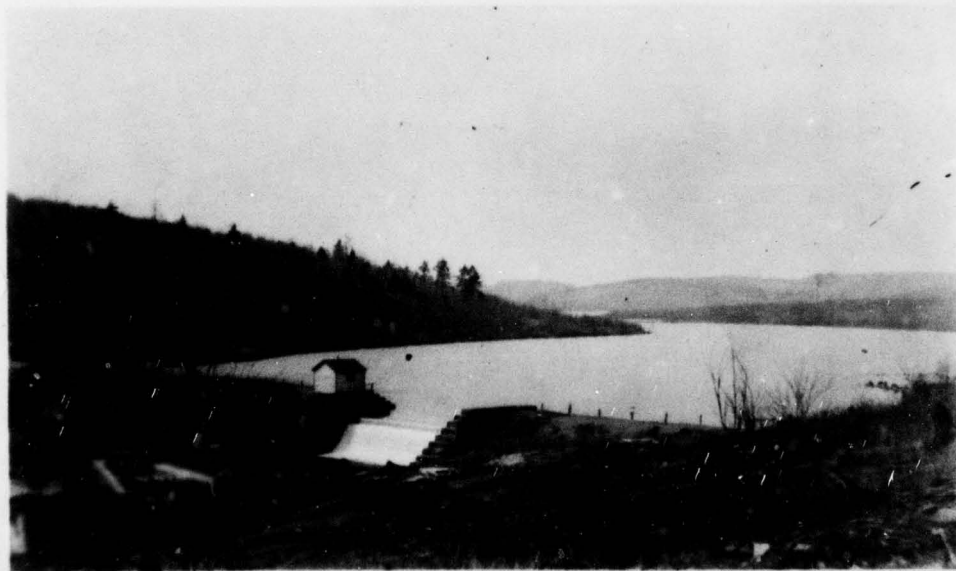
PHOTOGRAPH 2 View of DuBois Reservoir Dam showing temporary flume used during reconstruction.

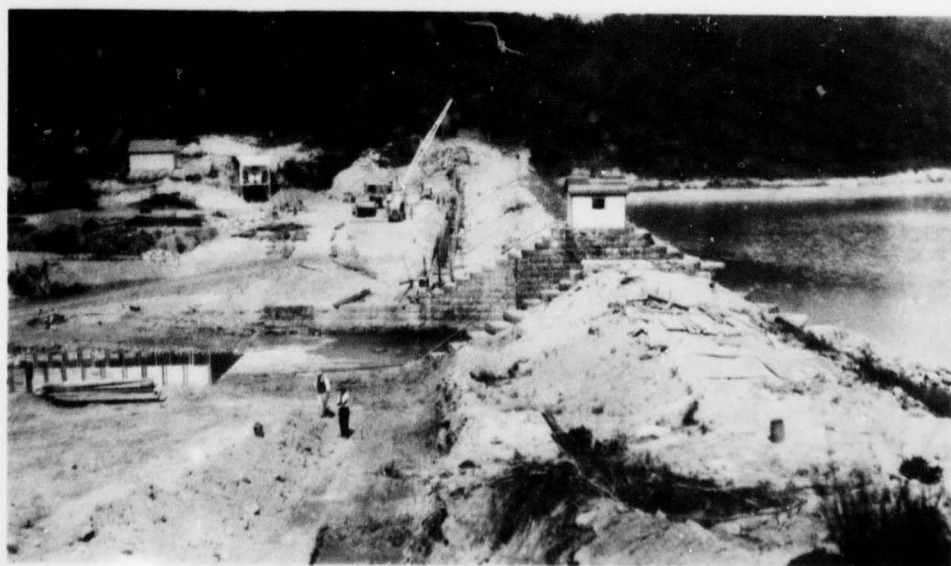
PHOTOGRAPH 3 View of DuBois Reservoir Dam under reconstruction in 1936. Note cutoff wall construction in the center of the photograph.

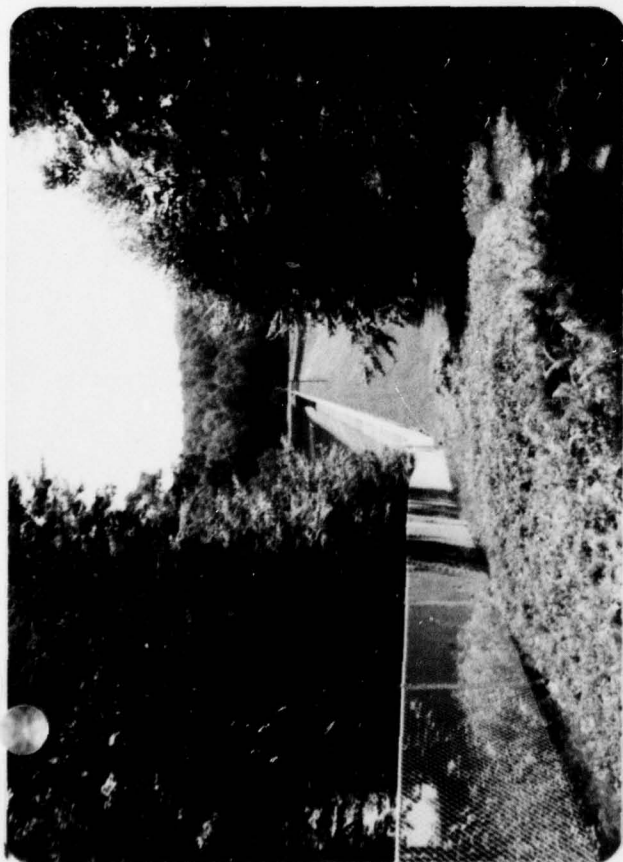
PHOTOGRAPH 4 View of DuBois Reservoir taken from the right abutment. The spillway is visible in the background of the photograph.

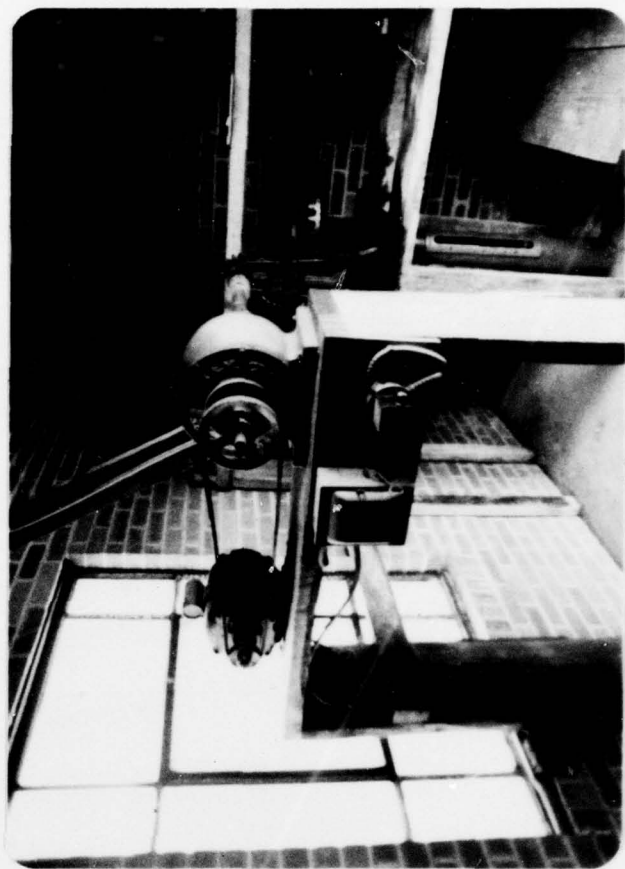
See Photograph 11 and Figure 5 - Electric motor now operates gate valve on
blow-off. Maintained on an as-needed basis.

PHOTOGRAPH 11 View of the interior of the brick building housing the controls on the blow-off line.

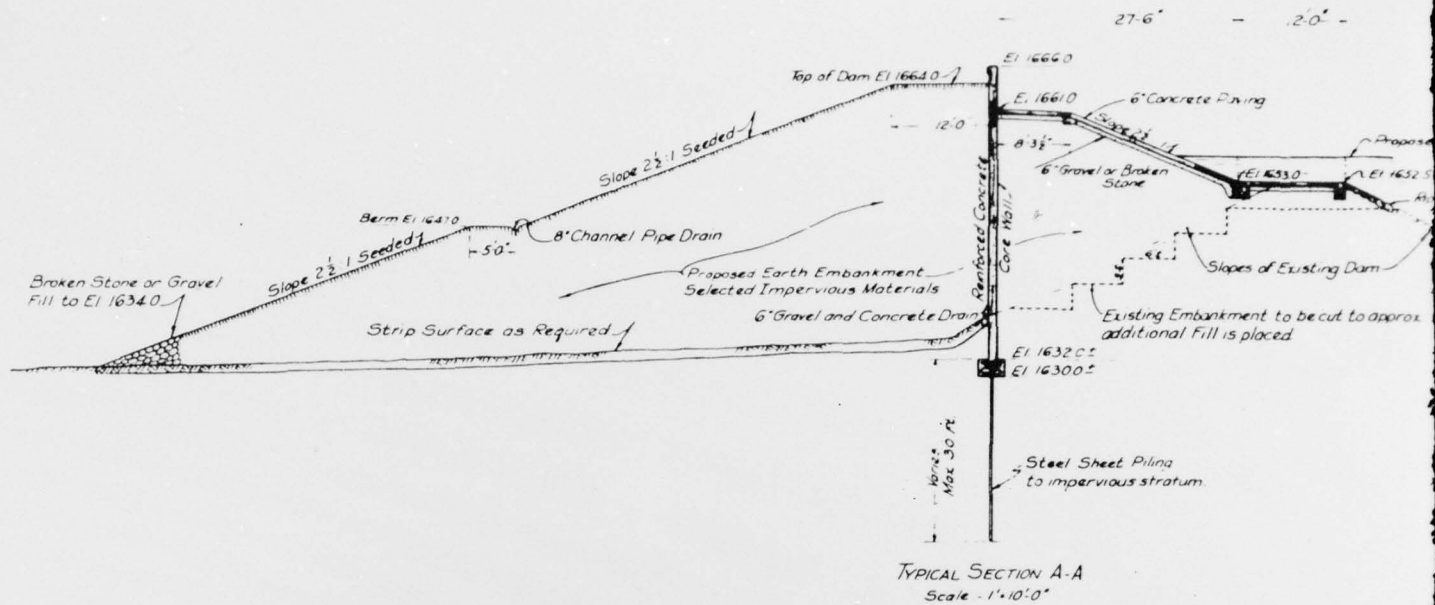
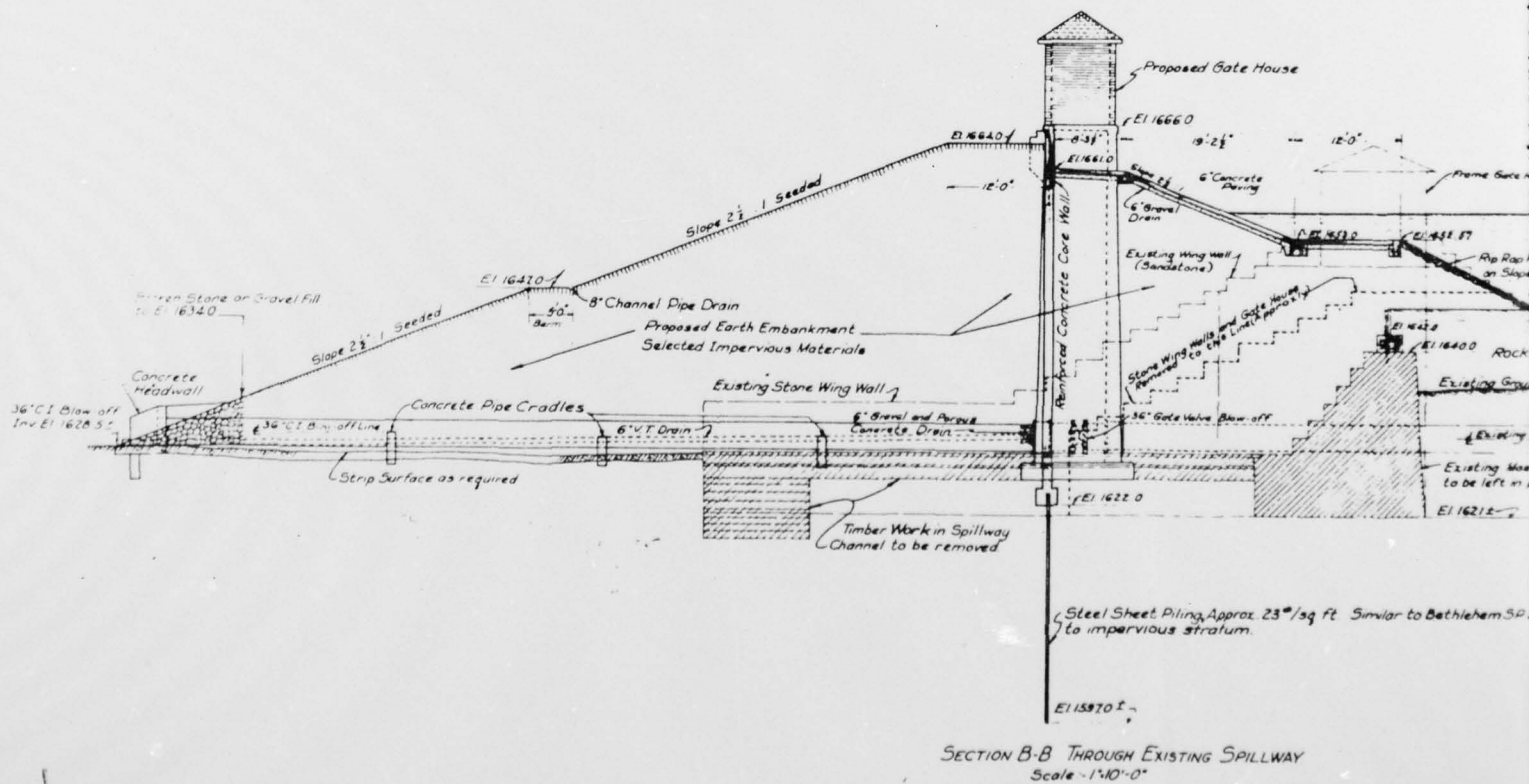
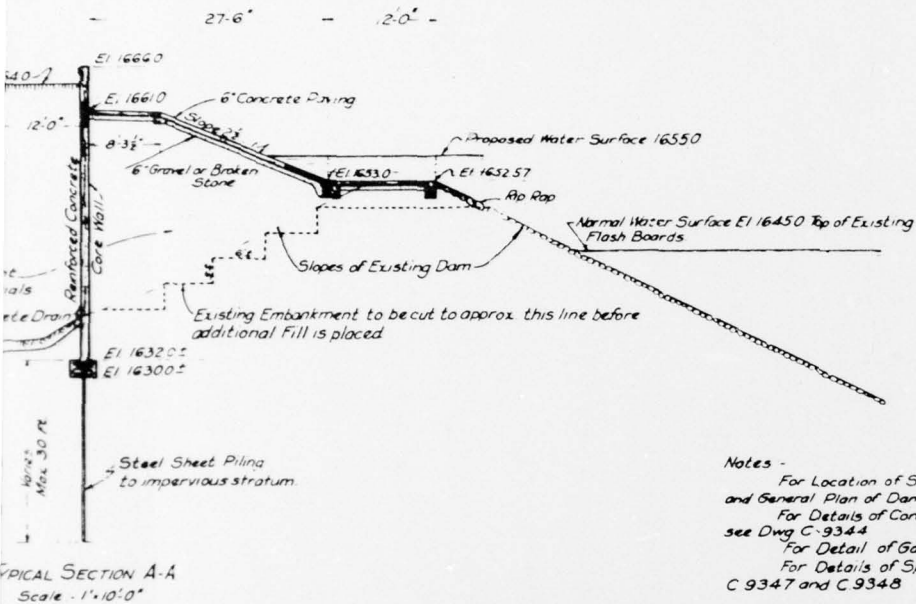
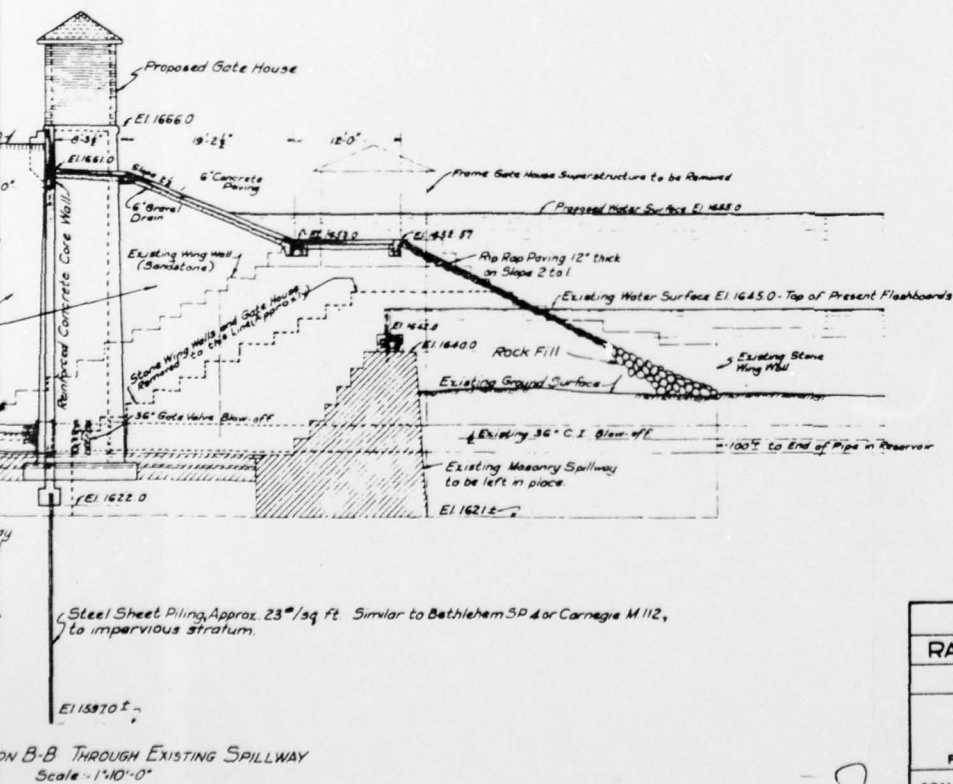
FIGURE 3

Impervious Core - A reinforced concrete core wall extends from the top of the dam at elevation 1686 to elevation 1642 (see Figure 3).

The upstream and downstream faces of the dam are sloped at 2.5H to 1V, the former being sloped at 2H to 1V below elevation 1673 (upstream face of old embankment) (see Figure 3). The upstream slope is faced with 12-inch stone riprap to elevation 1673. Above this elevation, the upstream face is provided with 6-inch thick concrete paving which is carried to the crest of the dam. The downstream slope of the dam is provided with a network of the drains which carry runoff away from the dam face.

b. Embankment. The upstream slope of the dam is faced with a 6-inch concrete paving which extends from elevation 1673 to 1681. Below elevation 1673 the upstream slope of the dam is protected by 12-inch thick riprap which once served as the upstream slope of the original dam (see Figure 3).
